Manhole Inspection Summary

Manhole # S13Q__027MH

Insp Date: **2/16/09 11:44 AM**

Location Address: **2804 WILKENS AV**

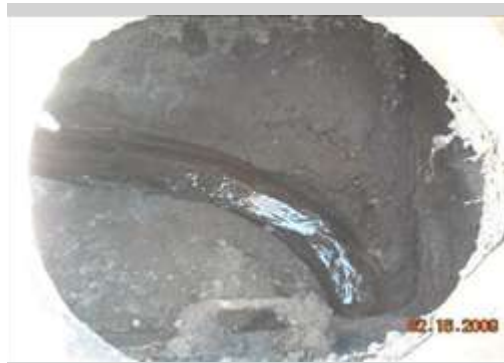
Top View

Pipe Out is under shelf

sediment buildup on bench

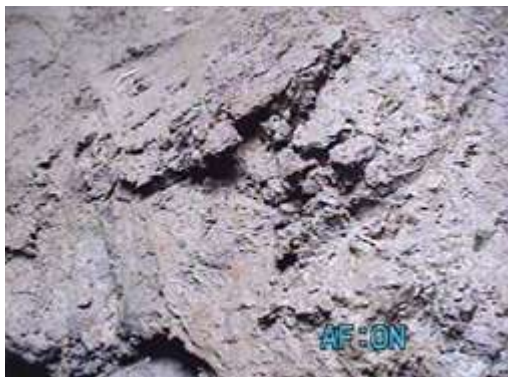
Defect 2

Condition: ☐ Sound ☐ Cracked ☐ Root Intrusion ☐ Deteriorated ☐ Leaks ☒ **Debris**

DEBRIS ON BENCH

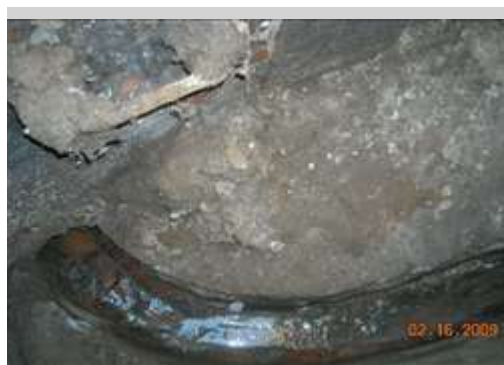
Defect 1

☒ **Evidence Of Surcharge** Depth: **2** (ft.) ☐ Active Surcharge Present

EVIDENCE OF SURCHARGE

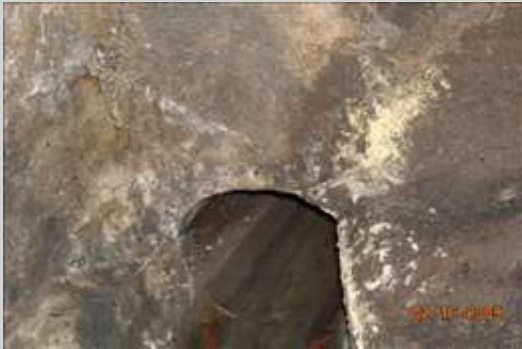
12 O'Clock Outflow

8 in. Circular Gravity Sewer
Pipe Out @ 12 O'Clock

Pipe Height: **8.4** (in.) Rod and Bar (Angled)
Pipe Material: **Clay** ☐ Pipe Lined
Invert Depth: **5.75** (ft.) Flow Characteristics: **Slow**
Deposits: ☒ None ☐ Mud ☐ Sludge ☐ Debris ☐ Grease
Silt Depth: **0** (in.) Deposits Extent:
Infiltration: **None** Pipe Seal Cond: **Unknown**

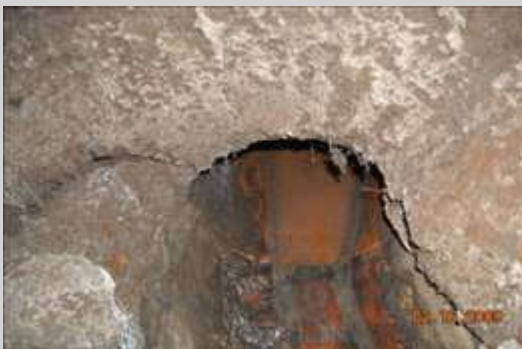
6 O'Clock Inflow

8 in. Circular Gravity Sewer
Pipe In @ 6 O'Clock

Pipe Height: **8.4** (in.) Rod and Bar (Angled)
Pipe Material: **Clay** ☐ Pipe Lined
Invert Depth: **5.00** (ft.) Flow Characteristics: **Slow**
Deposits: ☒ None ☐ Mud ☐ Sludge ☐ Debris ☐ Grease
Silt Depth: **0** (in.) Deposits Extent:
Infiltration: **None** Pipe Seal Cond: **Sound**
